GOVERNMENT OF INDIA  
MINISTRY OF CIVIL AVIATION  
(COMMISSION OF RAILWAY SAFETY)

RAILWAY ACCIDENT INVESTIGATION  
REPORT

~~DERAILMENT~~ OF T034 UP LUCKNOW-BOMBAY VT PUSHPAK EXPRESS  
(DIESEL ENGINE HAULED) AT KM. 1256/0-1 BETWEEN ATA AND ORAI  
STATIONS ON THE JHANSI-KANPUR SECTION OF JHANSI DIVISION  
OF CENTRAL RAILWAY AT 11.08 HOURS ON 17.05.1994.

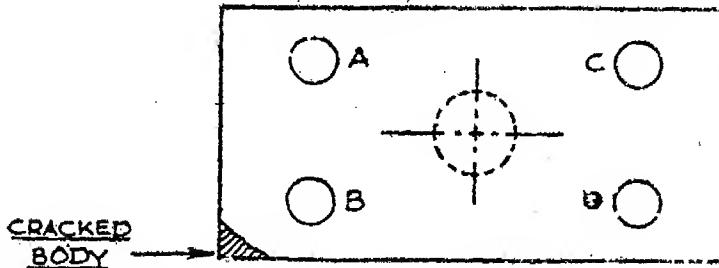
The above buffer was seen by the undersigned on 18-05-94 (during the final stage of restoration). The buffer was at the right hand leading end of the second coach from engine CR 8420. Two bolts of the buffer were found sheared off (A&B) in sketch below and other two bolts and nuts marked C&D were not available at site. Split pin of C was found available in the bolt hole. Buffer housing was found cracked near the 'B' bolt cover (see sketch below). The buffer had also left an impression on the JHS end panel of coach (the panel was found pressed).

On a close scrutiny of the buffer (vide photo at Annexure-II), it was noticed that there were certain marks on the rim of the plunger disk (buffer face) while main housing was free of any marks. Normally, if a buffer falls on the track and if a wheel passes over it, a wheel load of nearly 5.5 tonnes should definitely be able to leave distinct mark on the buffer. Even granting that the buffer bolts were deficient prior to accident (the bolts and nuts at C & D could not be traced at site easily though they might have been mixed up with a lot of debris collected at site), the fallen buffer in its position would not have formed an obstruction, since there was a clear distance of not less than 25 cms from the face of rail available which would make the passage of wheels free. As such an obstruction coming in the way of train wheels is ruled out.

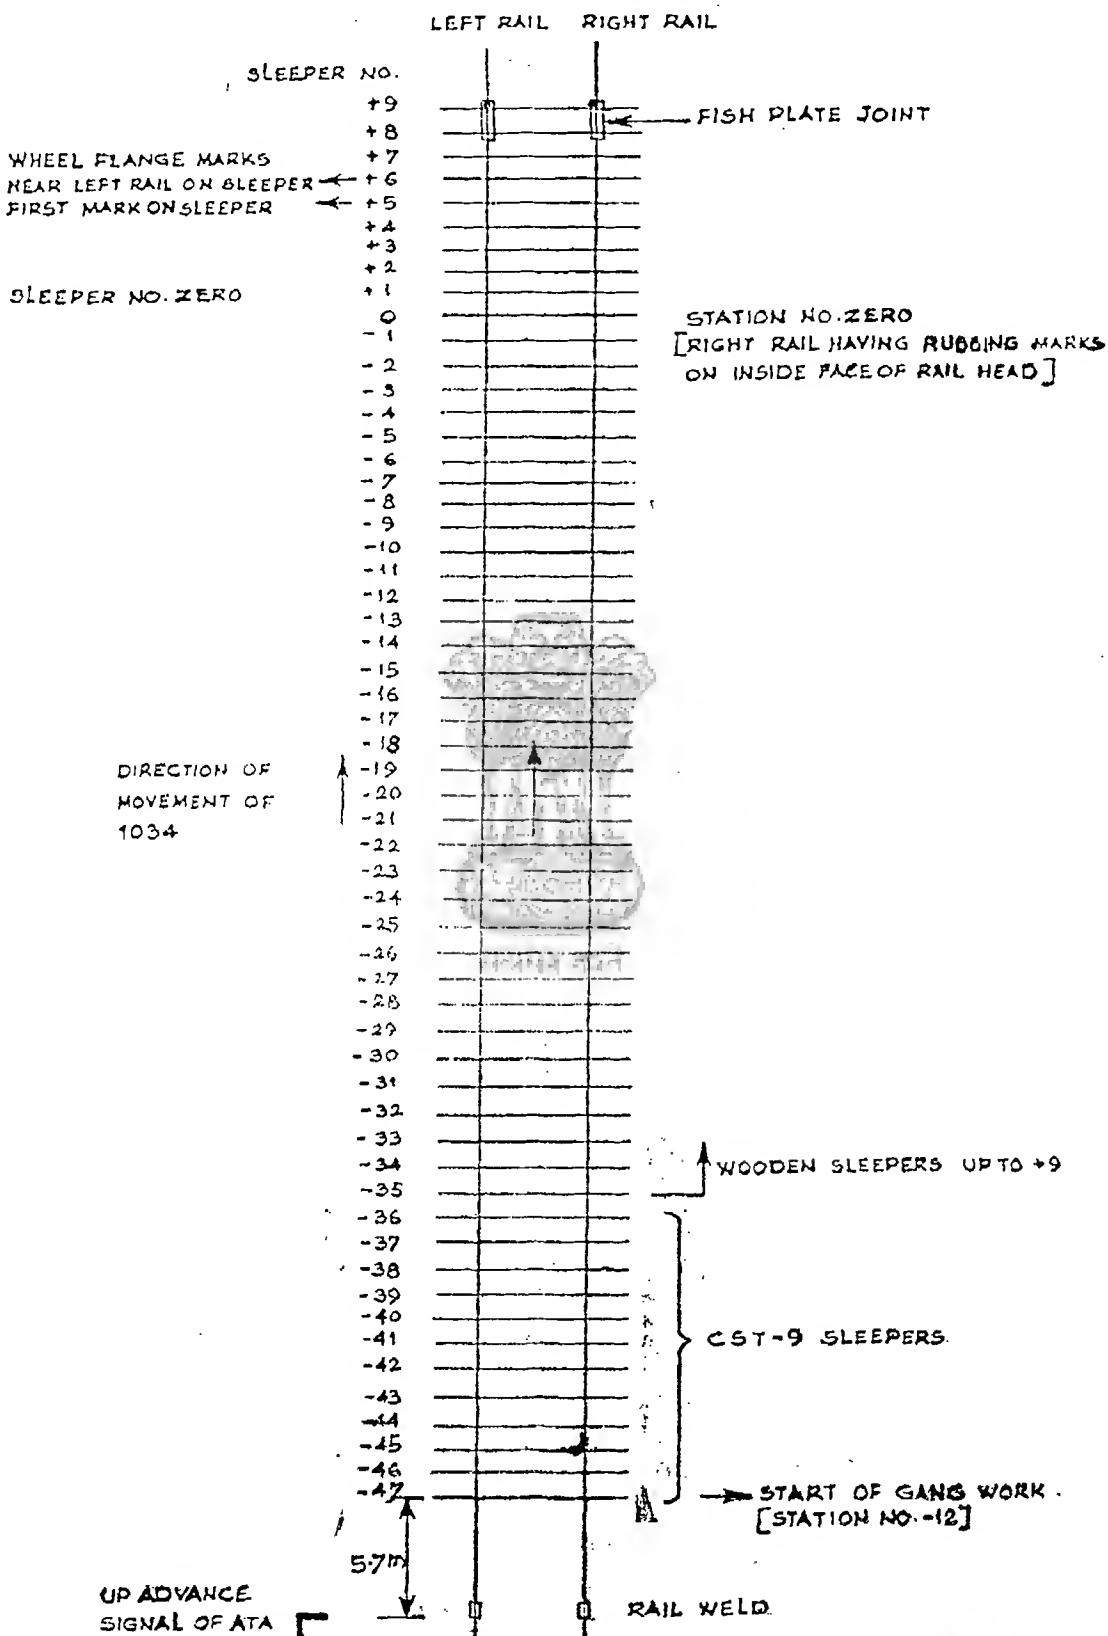
## B. DETAILS OF SLEEPER NEAR POINT OF DROP

Sleeper No.	Left rail fitting	Right rail fitting	Ballast	Sleeper type	Remarks
-19	Sleeper damage spikes worked out	Rail out of position	Shifted	Wooden ACB plates round spikes	Flange marks on sleeper near left rail.
-18	Sleeper cracked and one spike missing	Rail shifted all spikes broken from chair & sleeper cracked	"	"	Distance of flange mark different on sleeper No. 8 & 9 from rail foot.
-17	Sleeper crack	Chair sheet damaged	"	"	—
-16	Key missing	spike loose	"	"	Flange mark on sleeper near left rail
-15	Spike loose	spike loose key missing	"	"	First mark on wheel flange drop on sleeper near left rail. On right rail, rubbing impression on foot of rail.
-14	spike loose key loose	spike loose	"	"	—
-13	spike loose	spike loose	"	"	On rail foot, ACB plate & key rub mark noticed on right rail inside.
-12	spike loose	do.	"	"	do.
-11	spike little loose	do.	"	"	Rubbing mark on right rail foot inside.
0	spike loose	one key missing	OK	"	Right rail rubbing mark on rail head inside face

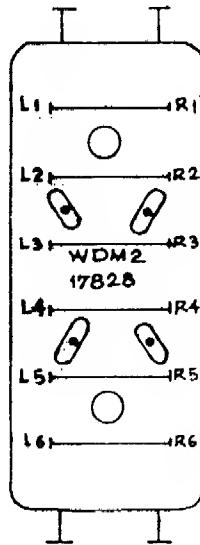
JOINT OBSERVATIONS ON WDM 2 17828 AT  
JHANSI LOCO SHED ON 19-5-94

## SHORT HOOD LEADING
